Bayside Home Inspections, LLC
104 Ewing Road
Ocean View DE 19970
302-500-0130
baysidehomeinsp@gmail.com www.baysidehomeinsp.com

Confidential Inspection Report
ADDRESS LINE 1
ADDRESS LINE 2
DATE

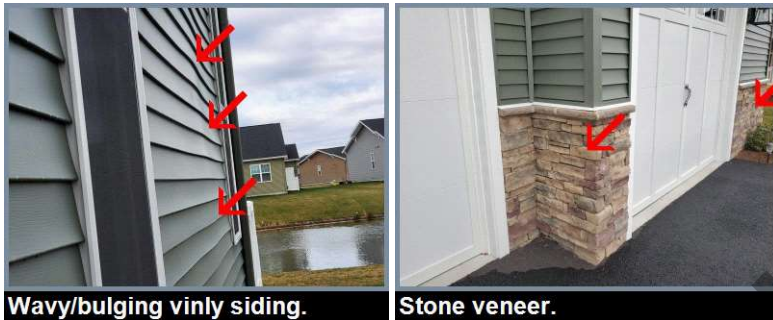
Walls covering are Vinyl siding and Stone. Siding was noted wavy/bulging at right side of home.

Wavy/bulging vinly siding.

Recommend calling a qualified trim siding contractor for further evaluation and repairs as needed.

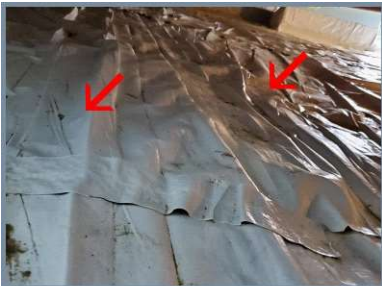
Moisture level was noted elevated on the surface of the floor vapor barrier.

Moisture at crawlspace vapor barrier.

Recommend builder install a dehumidifier to lower levels of moisture in the crawlspace.

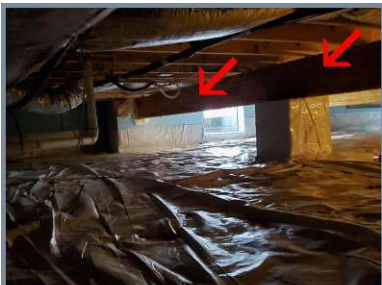
The main beam is made of layered dimensional lumber sandwiched together creating a built-up beam. Satisfactory - The main beam installed appears to be in satisfactory condition.

Main beam in crawlspace.

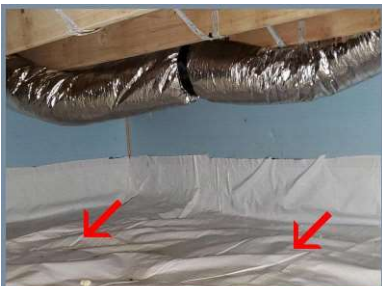
Soil, Vapor barrier is present. Type of vapor barrier was noted 6 mil reinforced polyethylene plastic sheeting over lapped at least 12 inches and sealed with tape.

Vapor barrier at floor of crawlspace.

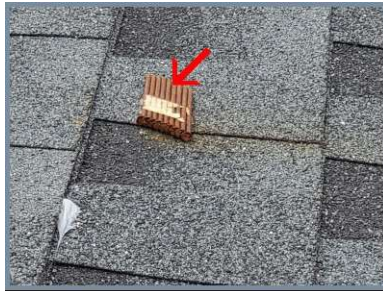
Nails on roof.

Recommend builder clean and remove excess nails.

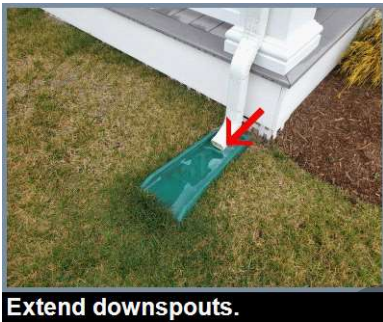
Building is fully guttered. Gutters and downspout materials are aluminum. Extend downspouts to route rainwater away from the building.

Extend downspouts.

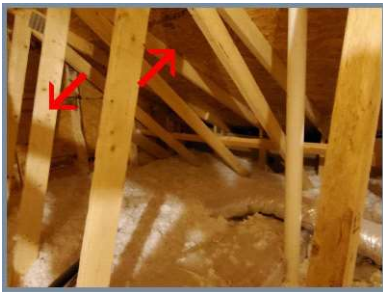
A truss system is installed in the attic cavity that is used to support the roof decking and transmit the roof load to the exterior walls. SHEATHING - The roof decking material is oriented strand board sheathing. The builder installed ply clips when installing the sheathing to prevent the sheathing from sagging at the joints.

Trusses and osb sheathing.

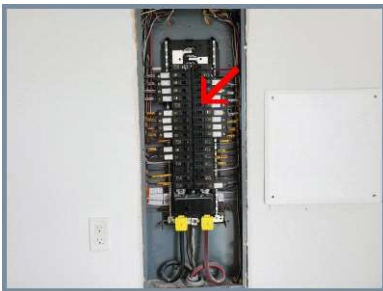
Circuit and wire sizing correct so far as visible. Grounding system is present. Arch fault circuit interrupters tested. Appears serviceable.

Main electrical panel in garage.

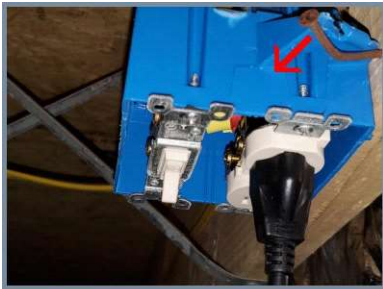
Missing or damaged cover plates viewed at the gas furnace location.

Missing cover plate in crawlspace.

Recommend calling a licensed electrical contractor for repairs/correction a needed.

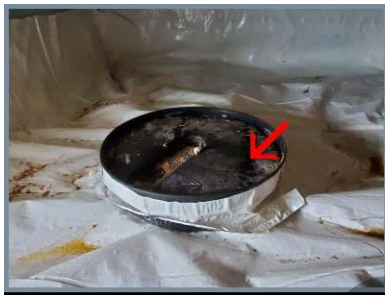
Sump pump pit.

Recommend builder install a sump pump to prevent water intrusion in crawlspace.

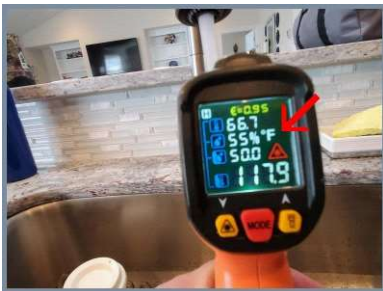
Appears serviceable. Pressure relief valve noted, not tested. Flue vent intact. Water temperature at kitchen sink 117 F.

Water temperature at kitchen sink.

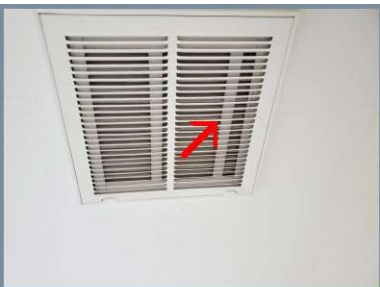
Air filters are located at all the upstairs bedrooms. The filter is clean and correctly installed. It is recommended that the filter(s) be changed or cleaned every 30 to 45 days for best performance. Size was 14x14x1.

Air filters.

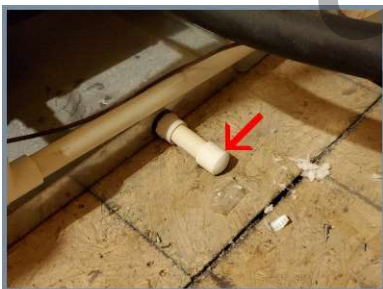
Incomplete secondary condensate drain.

Recommend calling a licensed HVAC contractor for further evaluation, correction/repairs as needed.

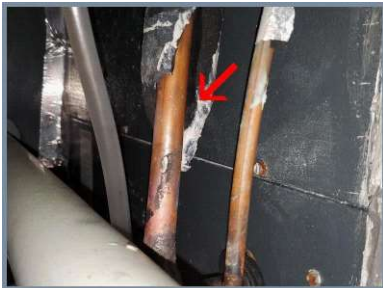
Unit not tested due to temperatures below 65 degrees. HVAC suction line is missing insulation.

Missing/damaged insulation.

Recommend calling a licensed HVAC contractor for repairs/correction as needed.

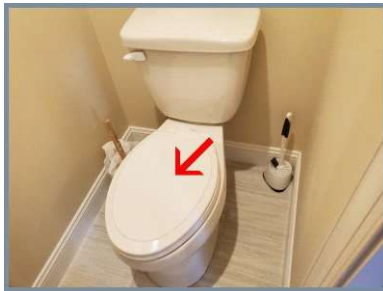
The toilet bowl was loose at floor in the master bathroom.

Loose toilet in master bathroom.

Recommend calling a licensed plumber for repairs/correction as needed.

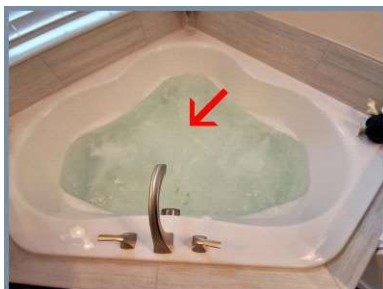
Jetted tub at master bathroom.

This presents a safety hazard and should be corrected by a licensed plumbing contractor.

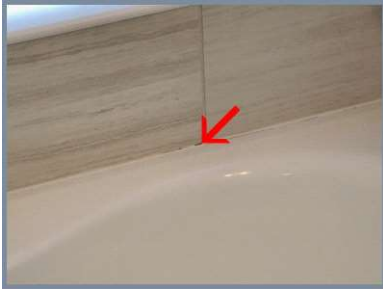
Ceramic Tile. Shower wall appears serviceable. Caulk and seal all tub and shower areas to prevent water infiltration at the jetted tub in the master bathroom.

Missing caulk at jetted tub / master bath

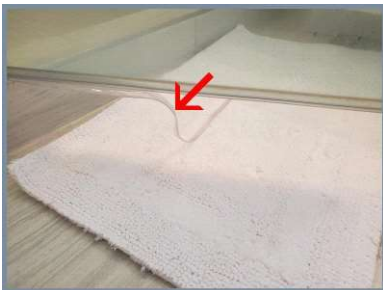
Damaged sweep was noted at the bottom of the master bathroom shower door.

Damaged shower door sweep.

Recommend replacement to water leakage.

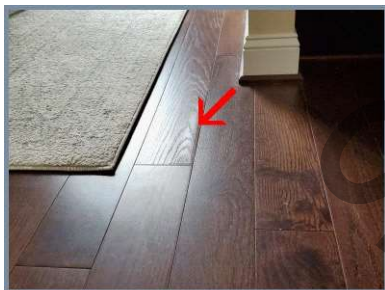
Engineered Wood, Ceramic Tile, Carpet. Damage/deterioration is noted at the dining room floor. Floor appeared to be uneven.

16.4 Condition:					
<input type="checkbox"/>	<input checked="" type="checkbox"/>	<input type="checkbox"/>	<input type="checkbox"/>	<input type="checkbox"/>	Engineered Wood, Ceramic Tile, Carpet, Damage/deterioration is noted at the dining room floor. Floor appeared to be uneven.
Recommend further evaluation and repairs as needed by a licensed contractor.

Uneven flooring in dining room.

Recommend further evaluation and repairs as needed by a licensed contractor.

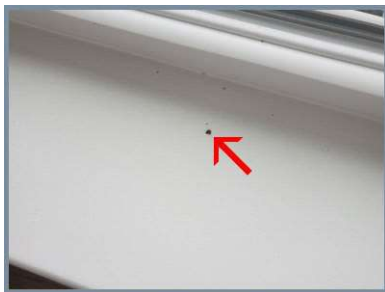
Trim at sunroom window.

Recommend setting nails and paint touch up at the window sill area of the sunroom.

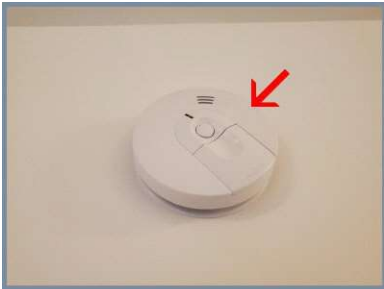
17.1 Comments:					
<input type="checkbox"/>	<input type="checkbox"/>	<input checked="" type="checkbox"/>	<input checked="" type="checkbox"/>	<input type="checkbox"/>	Combination Smoke Detector/Carbon Monoxide Detector.
Smoke detectors did not respond to test buttons in several locations.					
Recommend calling a licensed electrical contractor to make corrections/repairs as needed.

Combo Smoke/Carbon Monoxide detector.
