Bayside Home Inspections, LLC

Confidential Inspection Report ADDRESS

SAMPLE

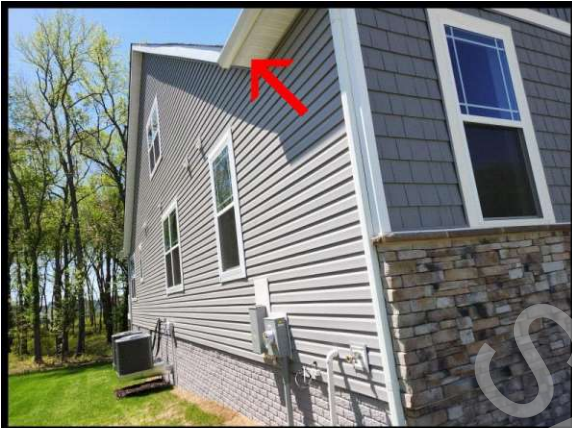
Exterior trim.

- Damage was noted at the front door trim..
- S MM SH MD CC
- Damage was noted at the front door trim..
- Damage was noted at the front door trim. Locations can be identified by blue tape. Builder correction is needed.

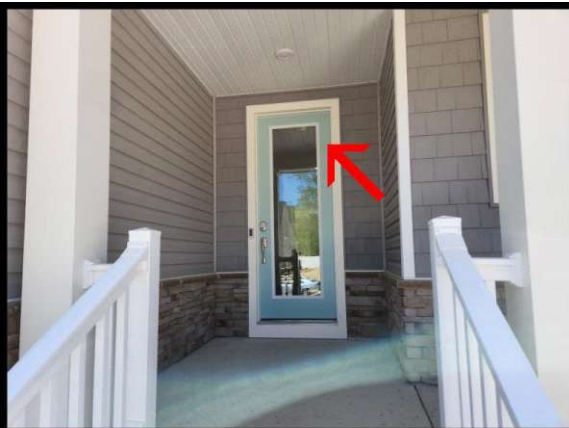
Exterior doors.

- Composite, Appears serviceable.
- The screen door was noted of the track at the basement walkout. Doors can be identified by blue tape. Builder Correction is needed.
- The doorbell was noted inoperable.
- Dents were noted at the front entry door threshold. Builder Correction is needed.

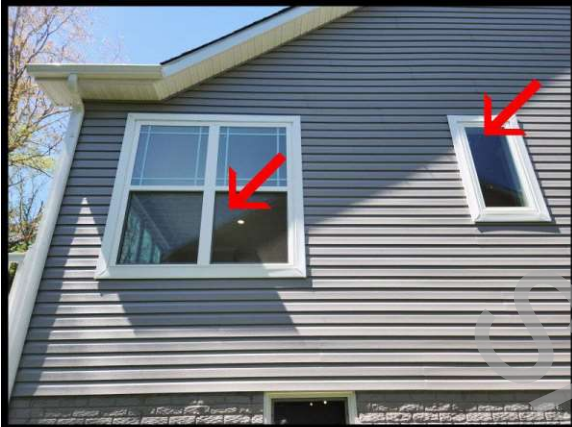
Exterior windows.

The window at the front bedroom was noted hard to operate. Windows can be identified by blue tape. Builder correction is needed.

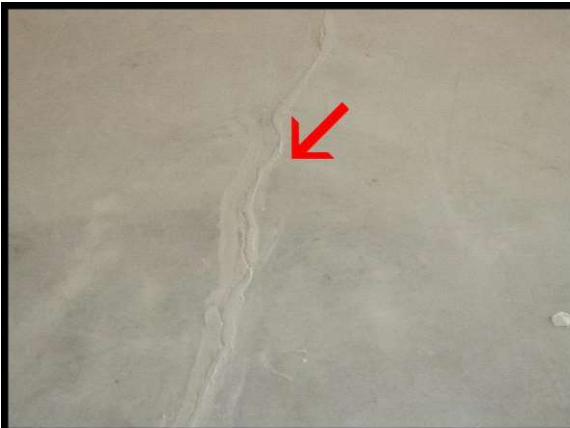
Basement floor.

Concrete, Typical cracks were noted and sealed. Monitor for any future movement.

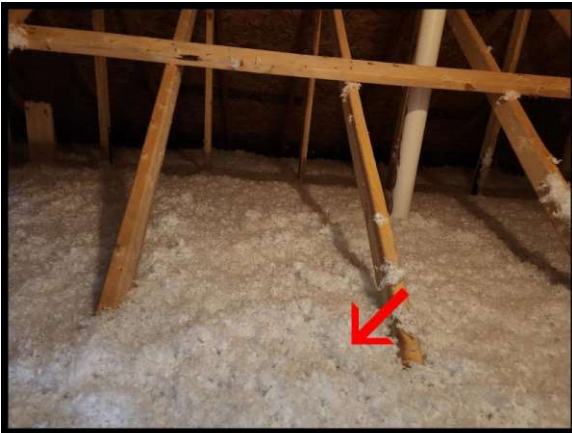
Attic insulation.

- Blown in fiberglass. Appears serviceable.
- Detached insulation was noted at the ceiling hatch. Builder correction is needed.

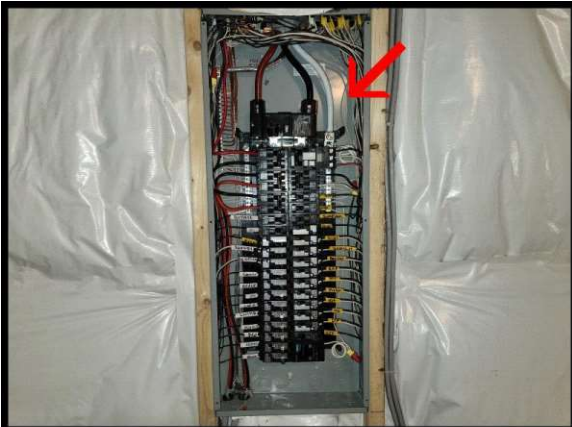
Main electrical panel.

- Circuit and wire sizing correct so far as visible. Grounding system is present. Appears serviceable.
- Missing screws were noted at the electrical panel. Builder correction is needed.

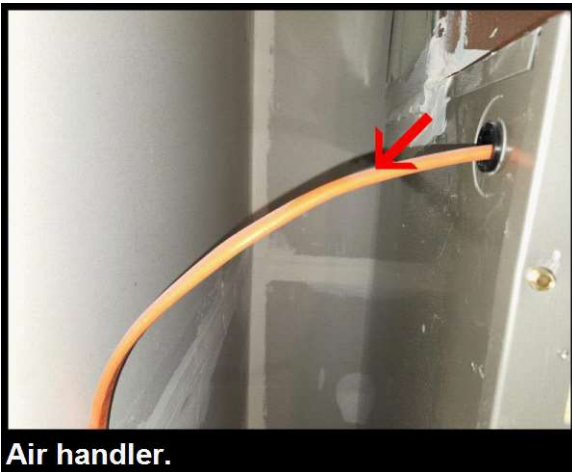
Air handler.

No disconnect switch was noted at the 2nd floor air handler. Builder correction is needed.

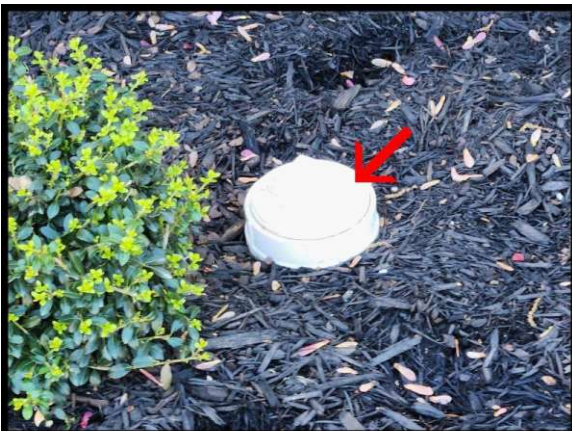
Sewer cleanout.

Sewer cleanout is located at the front of the home. Appears serviceable.

A plumbing fitting was noted at the right side of the basement ceiling. The inspector was unable to determine its purpose. Builder correction is needed.

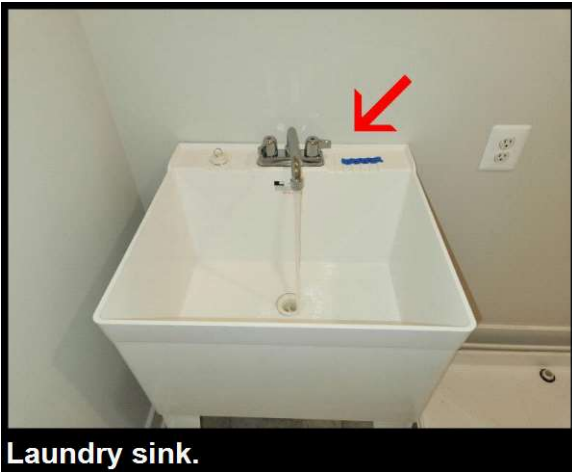
Laundry sink.

The laundry sink was not attached to the wall. Builder correction is needed.

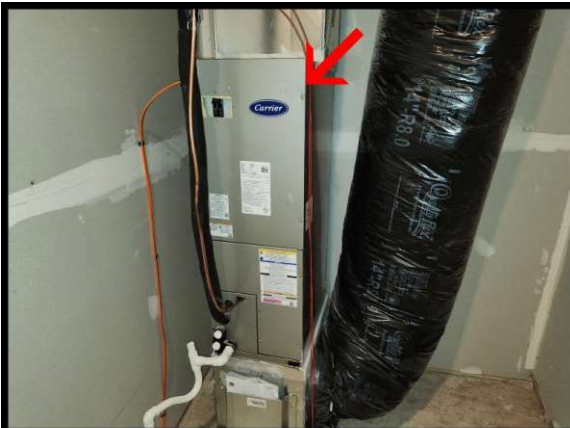
Air handler.

The plastic cover was noted missing at the electric backup heat circuit breaker. Builder correction is needed.

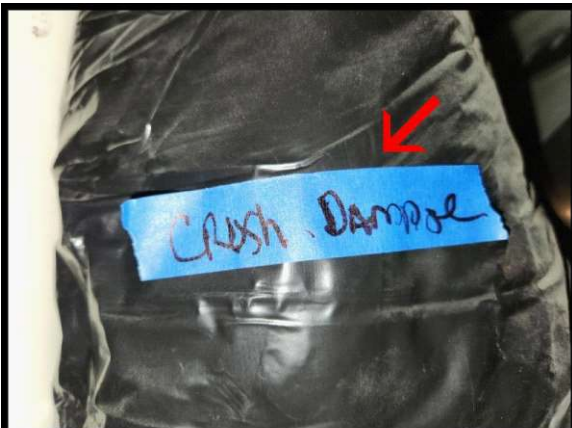
Ductwork.

- Insulated sheet metal. Flexible Round. Damaged/crushed/unsupported ductwork was noted at the basement ceiling at several location at the basement ceiling.
-
-
-
- Damaged/Missing register(s) noted at the ceiling adjacent to the water heater. Builder correction is needed.
- Damage ductwork was noted at the attic cavity. Builder correction is needed.

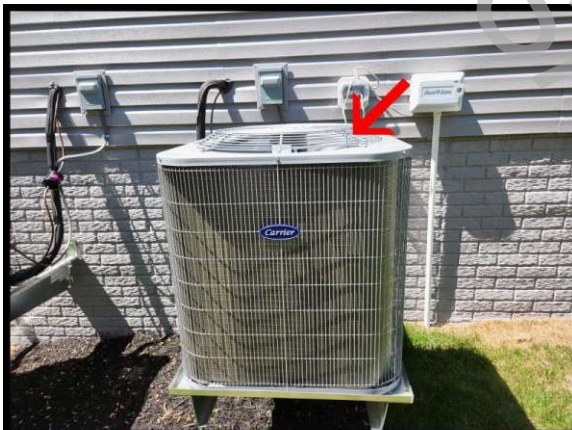
Outdoor condensing unit.

12.8 System Condition:
 Appears serviceable.
 Outdoor unit appears to be out of level and beyond the tolerance zone of 10 percent. Builder correction is needed.

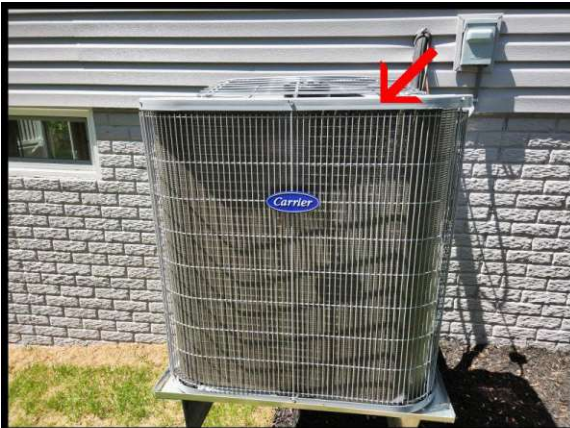
Outdoor condensing unit.

Refrigerant suction line is exposed and needs pipe insulation added. Builder correction is needed.

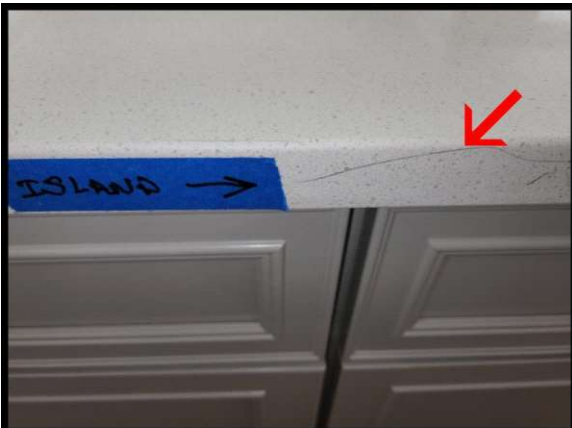
Kitchen interiors.

- Quartz Damage was noted at the kitchen island counter top. Builder correction is needed.
- Caulking is needed at the kitchen counter top to the left of the refrigerator. Builder correction is needed.
- Damage was noted at the base kitchen cabinet to the right of the refrigerator.
- Gaps were noted at the kitchen cabinet crown molding.
- Some cabinets drawers were noted not lining up. Damaged can be identified by blue tape. Builder correction is needed.

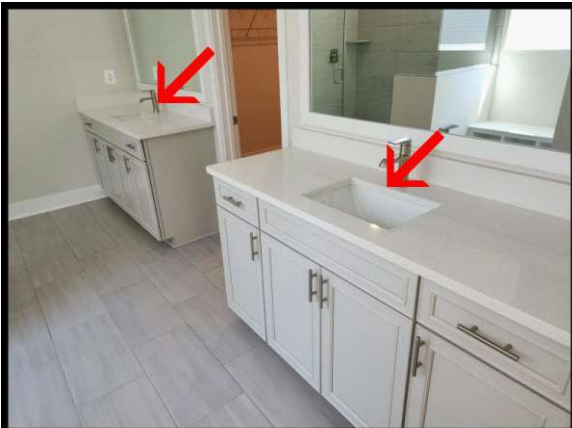
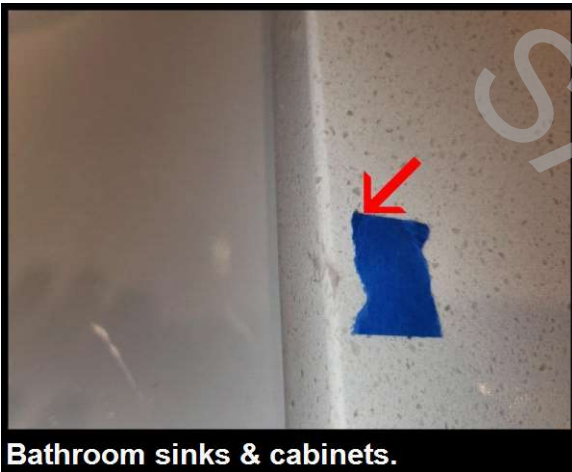
Bathroom sinks & cabinets.

- Appears serviceable.
- Damage was noted at the 2nd floor bathroom sink top. Builder correction is needed.
- Damage was noted at the 2nd floor bathroom sink top. Builder correction is needed.

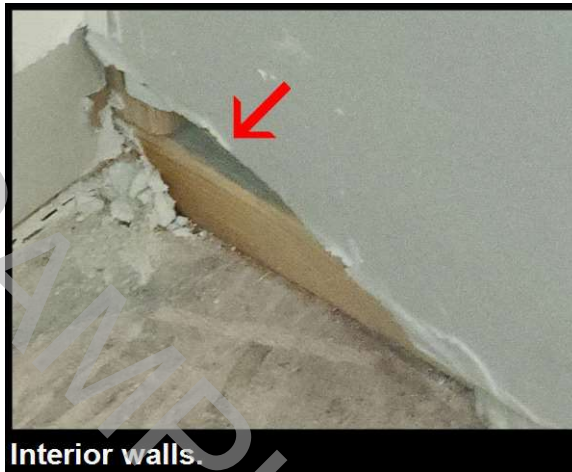
Drywall, Damage was noted at the wall to the left of the kitchen sink. Areas can be identified by blue tape.

Damage was noted at the 2nd floor utility closet. Builder corrections are needed.

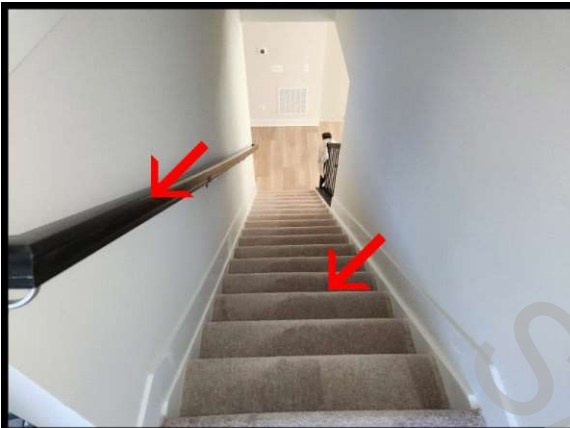
Interior stairs & handrails.

- Stairs and handrails appears serviceable.
- A creaking sound was noted at several steps. Builder correction is needed.
